## 2. INTERIOR MATERIALS

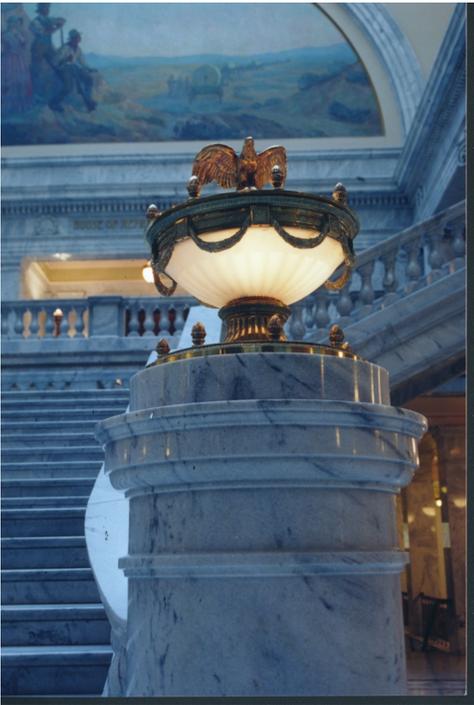
The interior stone is mostly intact, unaltered and in good to excellent condition. Most damage is minor and the result of normal wear and tear. For example, some of the lower, mitered corners of posts and walls have experienced minor chipping. Small pieces also have chipped off the noses of a few stair treads.

Preserve the original interior stone. Keep it clean and in good repair prior to renovation. Repairing minor, harmless chips is not necessary. Repair larger chips and damage with matching material and use matching Dutchmen when replacing major pieces. Also retain and protect the Scagliola. Because it is a thin cement veneer rather than actual stone, it is more easily damaged and needs extra protective care.

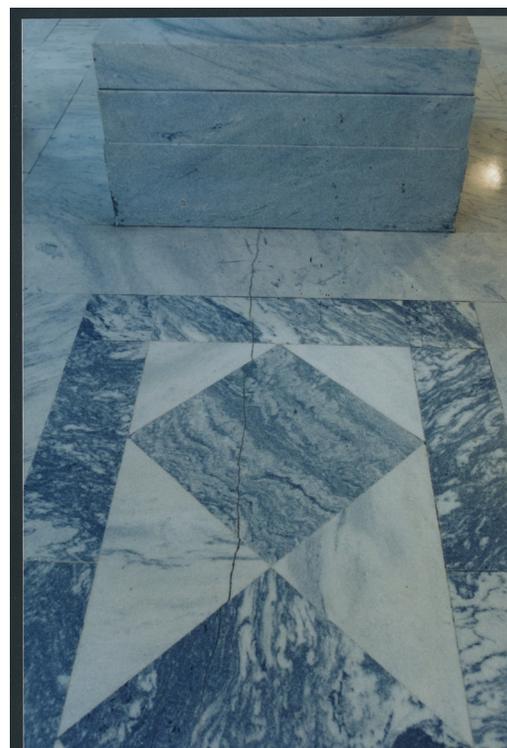
The most common tile deficiency, observed throughout the building, is cracking. Through-cracks quite regularly cross most of the tile floors, running through tiles and grout joints alike. The most likely cause of the cracking is movement of the floor and tile substrate.

The large cracks that striate the floors, especially on the first floor, should be patched. If areas that are currently tiled have in the past or will be disturbed during the rehabilitation, consider salvaging the tile from these areas as replacements. To remove tile from its substrate, soak in a 20-30% muriatic acid solution, testing first to determine the reaction of the tile to the acid, and to achieve the optimum strength and dwell time.

The tile repair should also address the cause of the cracking. The anticipated structural retrofit may lessen the movement that has caused the cracking up to this time. Expansion joints may be necessary to eliminate future cracking entirely; however, it may be aesthetically more appropriate to live with some cracking, particularly if replacement tiles are available, than to break the expanse of tile with expansion joints.
